DOT/FAA/AR-99/57

Fuselage Burnthrough Protection for Increased Postcrash Occupant Survivability: Safety Benefit Analysis Based on Past Accidents

September 1999

Final Report

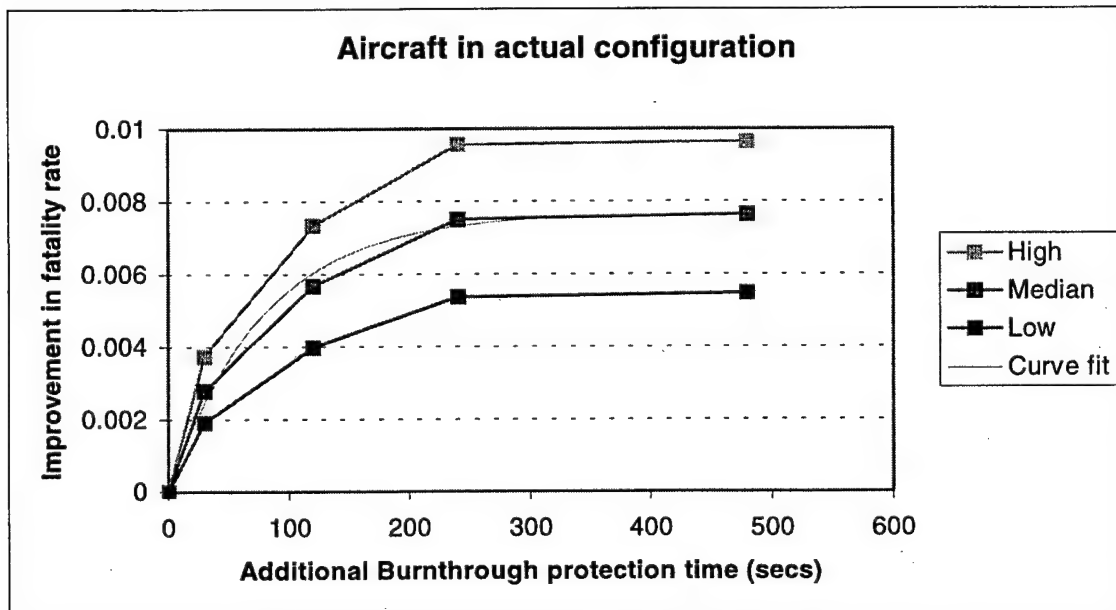
FIGURE 5. VARIATION OF IMPROVEMENT IN FATALITY RATE WITH ADDITIONAL BURNTHROUGH PROTECTION TIME FOR THE SEVENTEEN AIRCRAFT IN ACTUAL CONFIGURATION

The graph is shown overlaid with a least squares exponential curve fit for the median line having the formula $0.0077(1 - e^{(-0.013t)})$ where t is the additional burnthrough protection time in seconds.

It should be noted that the coefficient 0.0077 is the horizontal asymptote and represents the maximum assessed improvement in fatality rate with a perfectly fire-hardened fuselage.

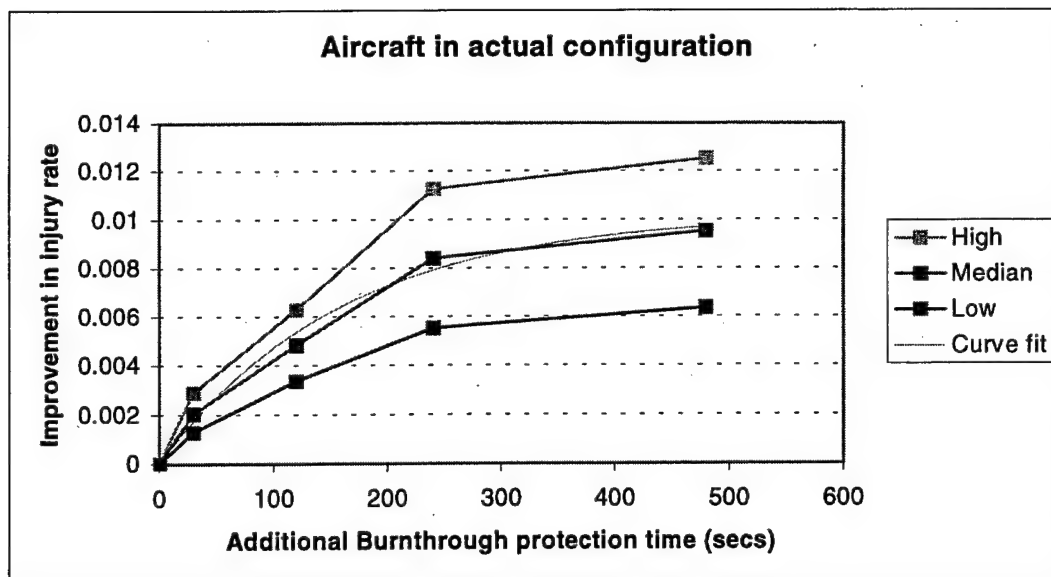
FIGURE 6. VARIATION OF IMPROVEMENT IN INJURY RATE WITH ADDITIONAL BURNTHROUGH PROTECTION TIME FOR THE SEVENTEEN AIRCRAFT IN ACTUAL CONFIGURATION

The graph is shown overlaid with a least squares exponential curve fit for the median line having the formula $0.0102(1 - e^{(-0.0063t)})$ where t is the additional burnthrough protection time in seconds.

It should be noted that the coefficient 0.0102 is the horizontal asymptote and represents the maximum assessed improvement in injury rate with a perfectly fire-hardened fuselage.

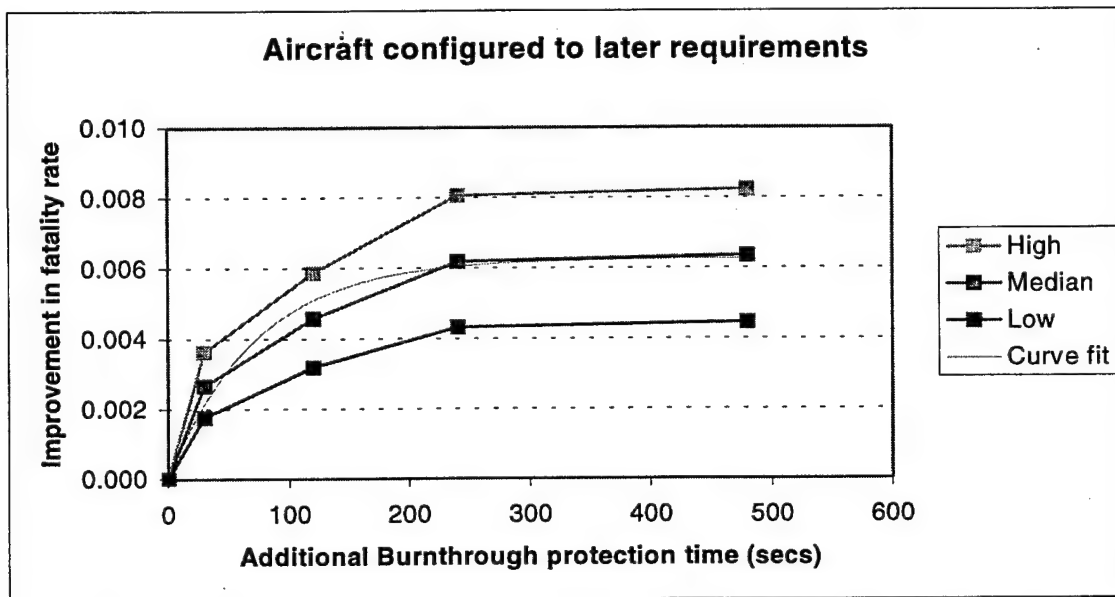
FIGURE 7. VARIATION OF IMPROVEMENT IN FATALITY RATE WITH ADDITIONAL BURNTHROUGH PROTECTION TIME FOR THE SEVENTEEN AIRCRAFT CONFIGURED TO LATER REQUIREMENTS

The graph is shown overlaid with a least squares exponential curve fit for the median line having the formula $0.0063(1 - e^{(-0.014t)})$ where t is the burnthrough protection time in seconds.

It should be noted that the coefficient 0.0063 is the horizontal asymptote and represents the maximum assessed improvement in fatality rate with a perfectly fire-hardened fuselage.

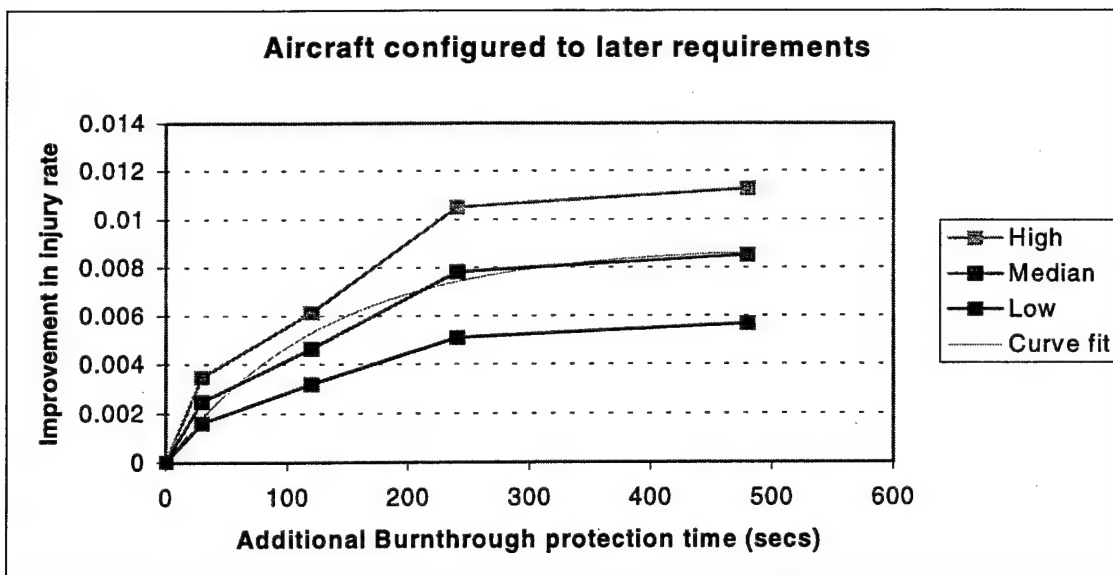
FIGURE 8. VARIATION OF IMPROVEMENT IN INJURY RATE WITH ADDITIONAL BURNTHROUGH PROTECTION TIME FOR THE SEVENTEEN AIRCRAFT CONFIGURED TO LATER REQUIREMENTS

The graph is shown overlaid with a least squares exponential curve fit for the median line having the formula $0.0088(1 - e^{(-0.0076t)})$ where t is the burnthrough protection time in seconds.

It should be noted that the coefficient 0.0088 is the horizontal asymptote and represents the maximum assessed improvement in injury rate with a perfectly fire-hardened fuselage.

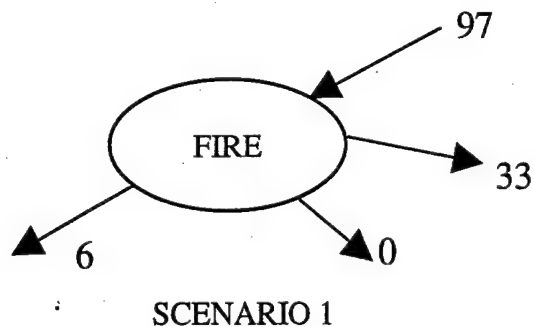
Scenario 1 contains the main cabin area. Evacuation was carried out through a fuselage break because the left exits were jammed and the right exits were blocked by fire. The scenario contains the 97 occupants including crew and passengers.

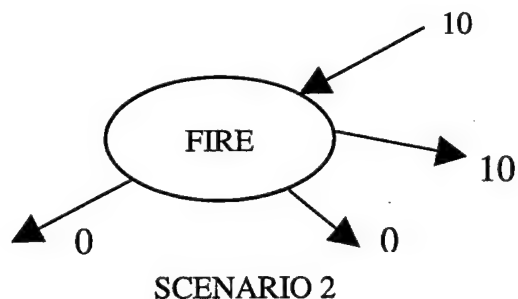
Scenario 2 contains 10 occupants who evacuated the aircraft but became trapped between two streams of burning fuel.

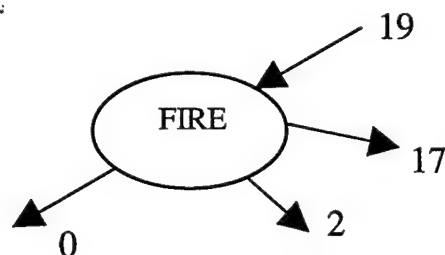
SCENARIO 2

Scenario 2 contains the main passenger cabin, which suffered internal fire and had only three of the ten exits available for egress. It includes all passengers and flight attendants. Many fatalities were found crowded in the galley area and overcome by smoke.

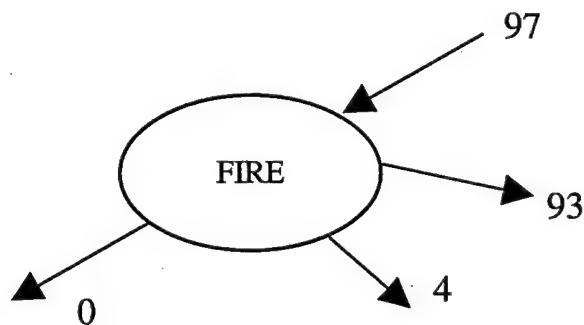
SCENARIO 2

Scenario 2 contains the main passenger cabin, which suffered internal fire and had only the two left overwing exits available for egress. It includes all passengers and flight attendants. Survivor statements indicate that the cabin occupants were moving up and down the cabin trying to locate and open exits. Most were found overcome by smoke crowded near the exits.

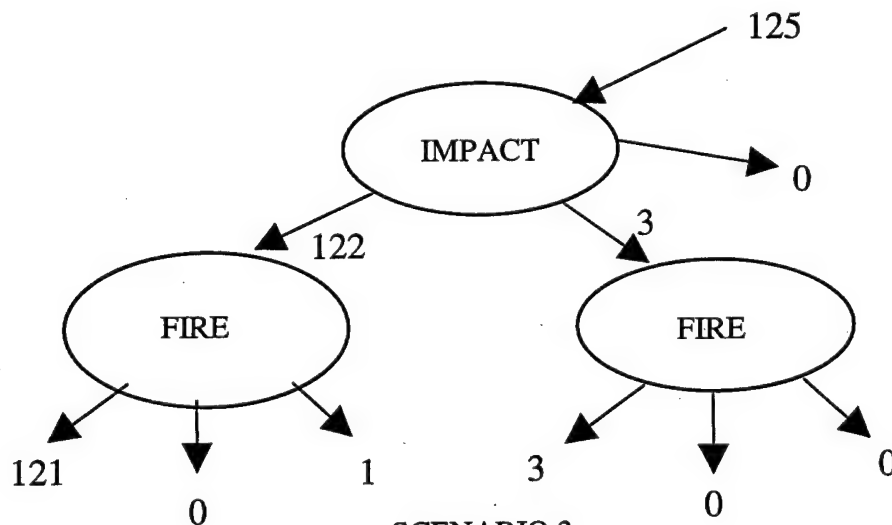
SCENARIO 3

Scenario 3 contains the main passenger cabin, which suffered internal fire after the initial impact. The scenario contains 125 passengers.

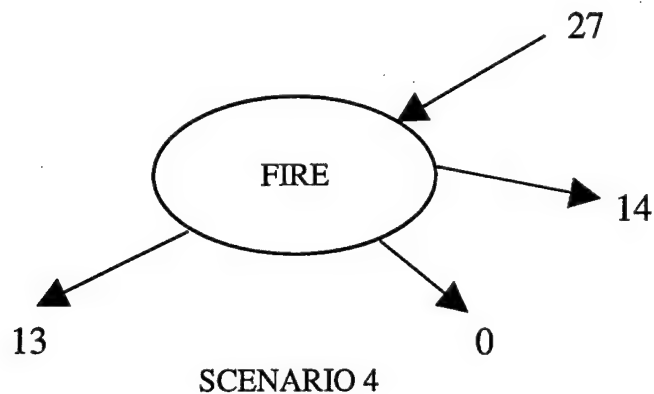
Scenario 4 contains the midsection of the passenger cabin from seat row 21 to seat row 26 inclusive. A uniform distribution of passengers was assumed; therefore this scenario contains an estimated 27 passengers, 14 of whom succumbed to the fire.

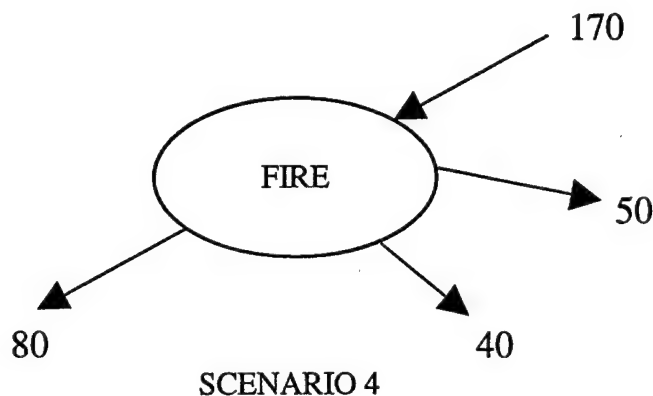
Scenario 4 contains the rear passenger cabin area where 50 occupants did not have sufficient time to make their way to the open L3 exit. The scenario contains 167 passengers and 3 flight attendants.

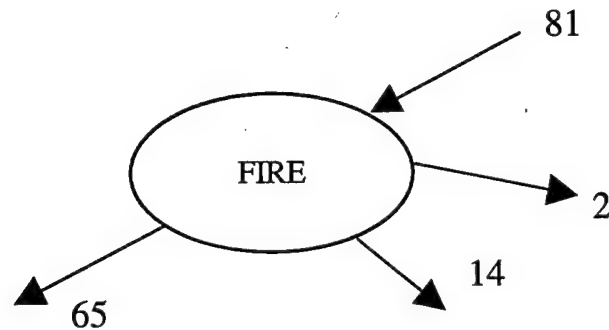
SCENARIO 4

Scenario 4 contains the passenger cabin from the front fuselage break just in front of seat row 2 to the rear fuselage break at seat row 27 inclusive. All injuries were sustained from the external fire which entered the cabin through the breaks in each end and by way of a burnthrough from underneath the centre wing box area. The two overwing exits L2 and L3 were available for egress along with fuselage breaks.

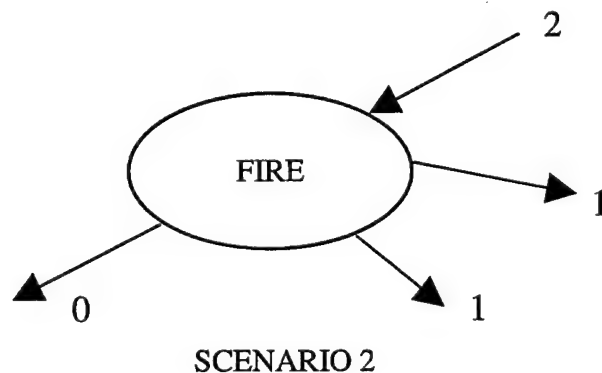
Scenario 2 contains the forward flight attendant vestibule area. This was the area in which fire first penetrated the passenger cabin. Visibility was restricted by very thick smoke. The scenario contains two flight attendants. The unknown injury was assumed to be serious and as a result of the fire.
